Water sharing and conflicts in the Wadi Laba spate irrigation system, Eritrea¹

Abraham Mehari Haile², Bart Schultz³ and Herman Depeweg⁴

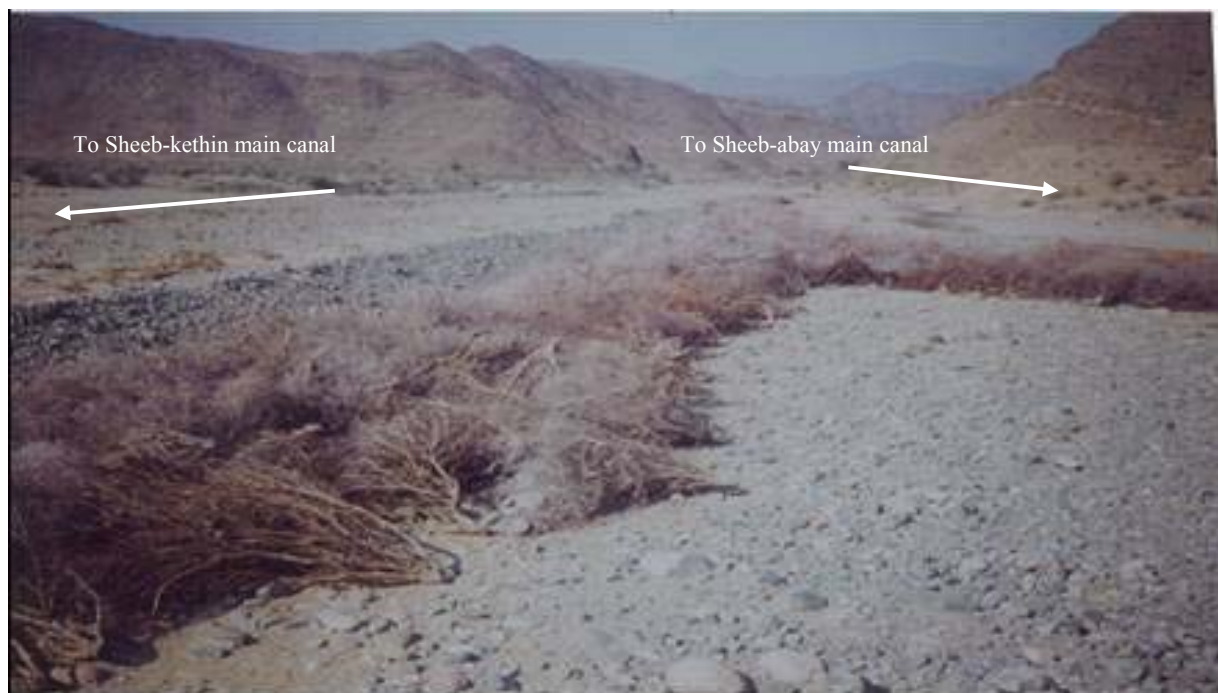
Figure 3: Traditional diversion structure, the *jelwet* (Photo by Author¹)

At the main system, water has to be divided proportionally between the two main canals: Sheeb-kethin and Sheeb-abay. This is done by adjusting the two wings of the traditional diversion structure, the ⁵*jelwet* (fig 3), in accordance with the needed proportionality. The committee members, through their years of experience, they can predict with greater certainty the onset of flood. Several hours or a day before the expected flood, all the committee members (group leaders) gather at the *jelwet* and make on site decisions as to how the structure should be arranged to deliver the proportionality of water distribution agreed upon. This usually involves several hours of discussions and although it is mostly concluded with amicable understanding and collective decision, occasionally, disagreements and conflicts occur.

Rule no. 4 is perceived among the Wadi Laba farmers to be very important, as it creates an atmosphere of cooperation between the upstream and downstream farmers, which is a necessity for the sustainability of their irrigation scheme. This is mainly because the *jelwet* (fig. 3), which is built of stones and brush-woods, is usually washed away by high to moderate floods. Its reconstruction is beyond the labour and material cost of the upstream farmers, making the contribution of the downstream farmers invaluable. The interviewed downstream farmers and farmer leaders explained that had it not been for this rule, they would have not contributed for the reconstruction of the diversion structure. They understand that large floods could cause damages to their field structures, but they also know that they are better served by the water distribution system induced by these floods - "The free distribution". The downstream farmers underlined that they do not need the assistance of the upstream farmers to maintain or reconstruct their field structures.

The upstream farmers have through the years learned that, as long as the *jelwet* is timely and properly maintained, they will always be able to irrigate their fields with small floods. Hence, they have largely been abiding by the rule no.4. As stated earlier, however, as during the large floods, the water has to pass through their fields on its way to the downstream fields, they have a possibility to easily manipulate and violate the rule. Downstream farmers recall serious violations, particularly during the 1985 and 1989 flood seasons, which were induced by the acute shortage of spates. The upstream farmers used almost all the spate that occurred, leaving about 80% of the downstream fields un-irrigated. The tail-enders filed a complaint with the committee, but the case was peacefully settled, with the help of village elders without being communicated to the Local Administration. Based on the advice of the village elders, the committee decided that the following year, the upstream fields will only get water after the downstream fields have received two irrigation turns. This decision was fully implemented, paving the way for confidence building among the farmers.

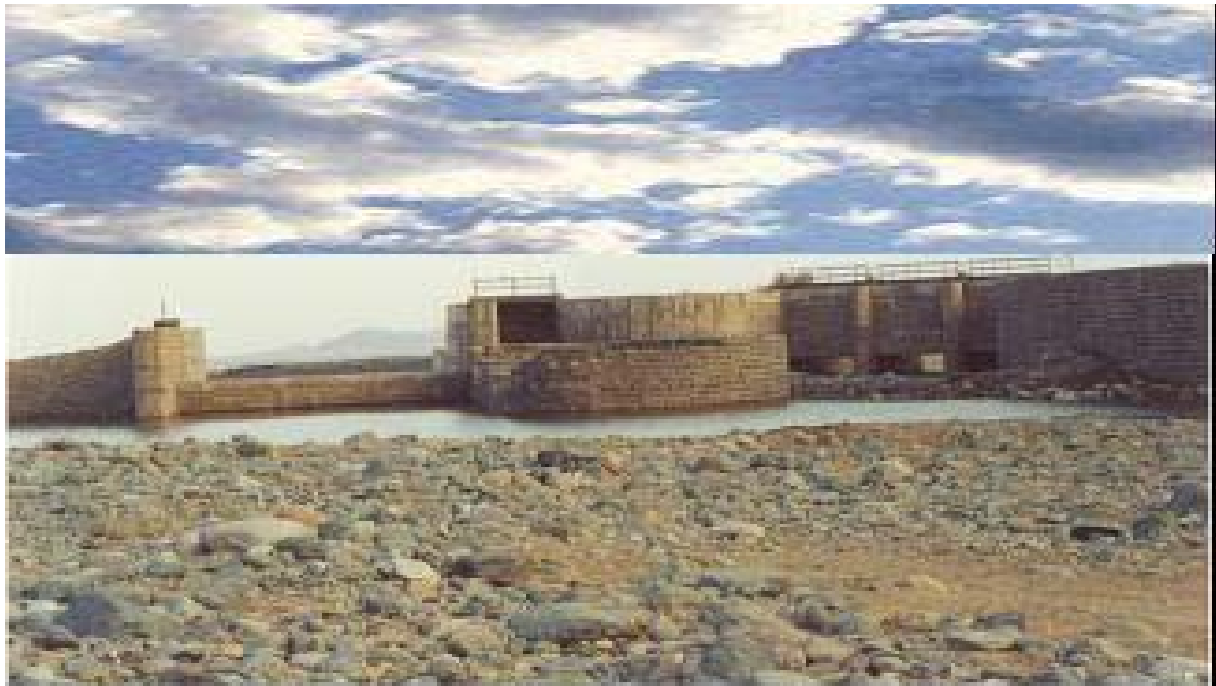
Figure 5: Undershot Wadi Laba diversion weir (Photo by Author¹)

As part of the efforts to modernise spate irrigation systems, the Ministry of Agriculture, with technical assistance from Halcrow Engineers and financial support from the International Fund for Agricultural Development (IFAD), established an Eastern Lowland Wadi Development Project (ELWDP). The project constructed a permanent concrete underflow diversion weir (fig.5) at two major Wadis, namely at Laba and Mai-Ule, completely replacing the *jelwet* (Halcrow, 1997). These new structures were intended to better control the spate floods and divert more water to the irrigated fields there by improving the crop yield. One of the main justifications for the replacement of the construction of the weir is that traditional structures are frequently washed away in the middle of the flooding season and before they can be (re)constructed and/or maintained many spates are lost. This results in a huge loss of production. The worst scenario that could occur is that the *jelwet* could be washed away by the first flood in a certain season. Given the unpredictable nature of the floods, there may not be any flood after the *jelwet* was reconstructed, virtually resulting in no crop production. As far as the allocation and distribution of water from the Wadi to the main canals is concerned, the introduction of the weirs has resulted in an immediate shift of responsibility (at the main system level) from the group leaders to the gate operators. The “experienced eye” was replaced with the supposedly “accurate measurement” of the undershot gates.

The Wadi Laba weir became fully functional in the year 2002, which was a relatively dry year with a total of only nine spates. The farmers in Sheeb classify the flood season into excellent, good, average and dry, when the number of spates are above 25; 20 to 25; 15 to 20; and below 15 respectively. The farmers informed that the third flood that came early morning at around 2:00 AM, which had a depth of about 2.5 meters at the immediate upstream of the weir completely swept away the breaching bund. As the gate operators were given an instruction by the project team to keep the scour sluice gate closed, and only open it during large floods; the gate was closed and the gate operators in fear of their lives (as the flood was very large), they did not open it. Some of canal head regulator gates were also blocked with large tree-branches and boulders. These have significantly contributed to the total sweeping away of the reaching bund, which was built with a return period of five years. The breaching bund was constructed in such a way that once destroyed, the water is disposed into a non irrigable area, mainly to protect the fields from erosion and field structures from damage. This however has negative impact, especially in dry seasons, because it did not give farmers flexibility to benefit from “Free water distribution”, by converting part of the lost water. Although the downstream farmers were willing to combine efforts with the head-end farmers, the reconstruction of the breaching band was beyond their labour and material capacity, and even their technical ability as it involves many engineering aspects such the upstream and downstream slopes, which the farmers have not been informed about. The project team probably did not expect the incident and were unprepared and as claimed by some engineers, they had no dozers and loaders in place. The breaching bund was not reconstructed timely and all the seven spate floods that followed were lost.
